No. 71 and Corruption – Removing the Requirement for Enforcement

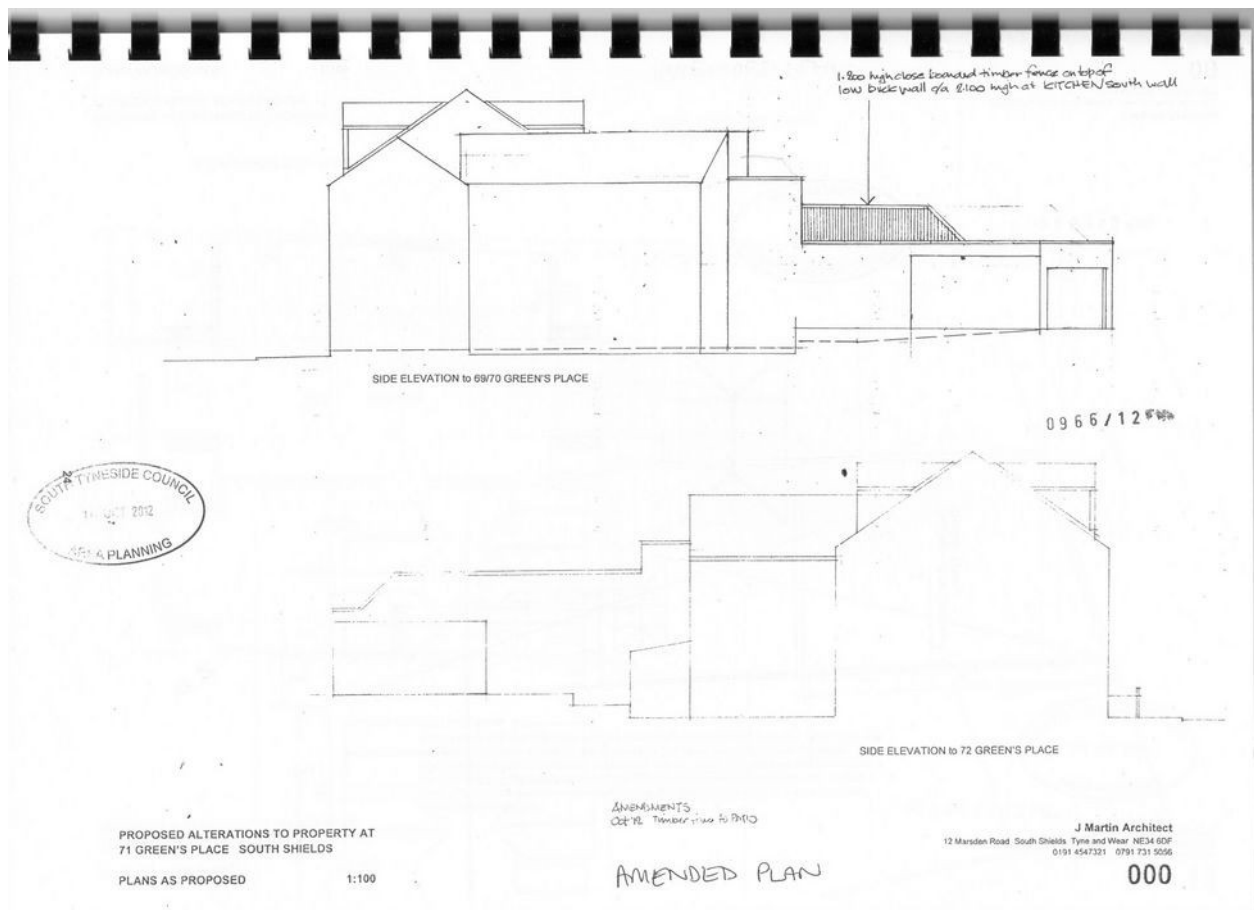
Mr Haig had instructed his builder to lay the wall about 15-20cm within his border to avoid it having to be called a party wall and the gap was never capped and we actually complained while the work was in progress but it was over the phone and we were ignored.

One can just make it out but J Martin Architect, has raised the roof line of the extension of 70 Greens Place, by about a meter, to that of extension of 72 so that the owner of 71 can raise the parapet wall by a bit over a meter in the knowledge that no-one would notice and in fact the owner of 71, Mr Haig, used this to his advantage and he not only replaced the fence with a solid wall and he extended it for extended for a couple of meters. This was not reported by the building inspector Mr M Telford.

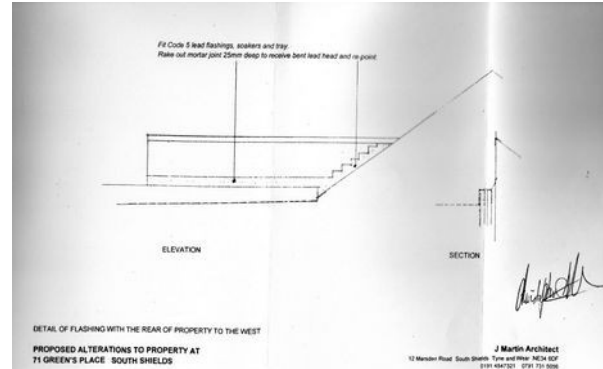
Detail of flashing etc. - see right.

The flat roof is gently sloped to take the run off rainwater from the pitched roof and should be about 20cm high extending to about 30cm (estimated) at the lower edge of the flat roof and the flashing another 20cm above that.

The owner of No. 71, Mr Haig, thought that if he built the wall with a gap between him and No. 70 he could void the party wall agreement. The flashing was never done.

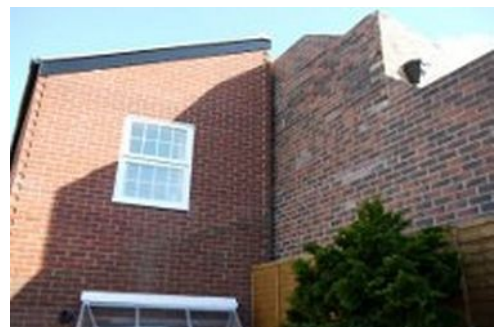
Please see the amount of over shadowing and state of the Party Wall – mid 2013 when the complaint that the rebuild 71 was not quite to plan, was sent in. One can plainly see that it no longer bore much resemblance to the permitted plan.

- 1) 150 – 200mm gap between the buildings;
- 2) complete absence of flashing per plan;
- 3) the meter extra height of the top wall. Its planned height is indicated by the top of the rain water goods and the change in quality of the brickwork;

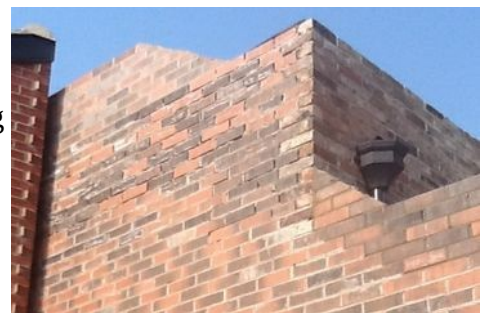
- 4) there is also the additional height of the wall, some 16 courses of brick, which also ran the full width of number 71;
- 5) the wooden fence, that is also very clearly shown in drawing 000, has been replaced by the brick wall and the bush pointed to where it should have started, at the back of the first floor to which the rainwater goods were fixed;
- 6) the extra height of the wall is indicated by the 5 courses of brick which had not dried when the photo was taken.
